Red Roof Nursery

Qudos
ENERGY

Supply for Static Caravans

Containment and Cabling

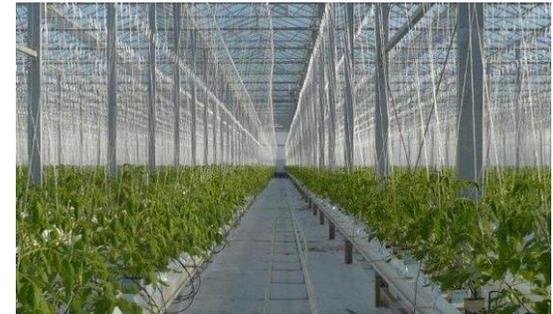
We were asked by Chris to supply electrics for two new static caravans situated on the Red Roof Nursery site, this was particularly tricky as there was no easy route to take from any distribution board nearby. Paul liaised with the on-site engineers and came up with a timely and effective solution.

We decided to follow the route of the heating pipes out of the boiler house/packing shed as there were metal posts to fit our shallow Unistrut and 100mm tray to. We then fitted a small enclosure with two RCBOs in to feed the caravans. The enclosure was fed from a local distribution board nearby.

To complete we tested the circuit we had installed, we also did a test and inspect on the static caravans and provided certification.

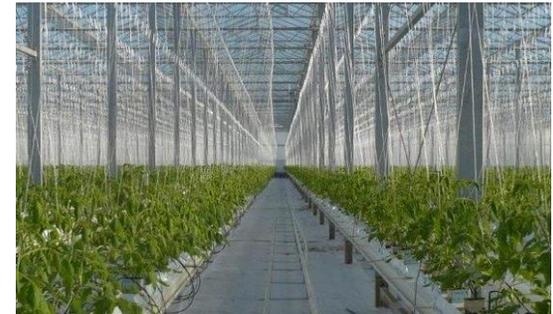
The most recent job was to help provide a route for new cables that feed Red Roof's new tomato packing system.

We fixed shallow Unistrut to the floor and attached a 100mm tray using short sprung nuts and 16mm roofing bolts. We then tidied all the cables onto the tray and cable tied the SY cable until it reached its desired points, ensuring the finish was of high quality and to the customers satisfaction.

Quality containment is an important part on any install and is also the most visible. If this is not done correctly issues can occur over time, requiring expensive work to reinstall and rewire.
